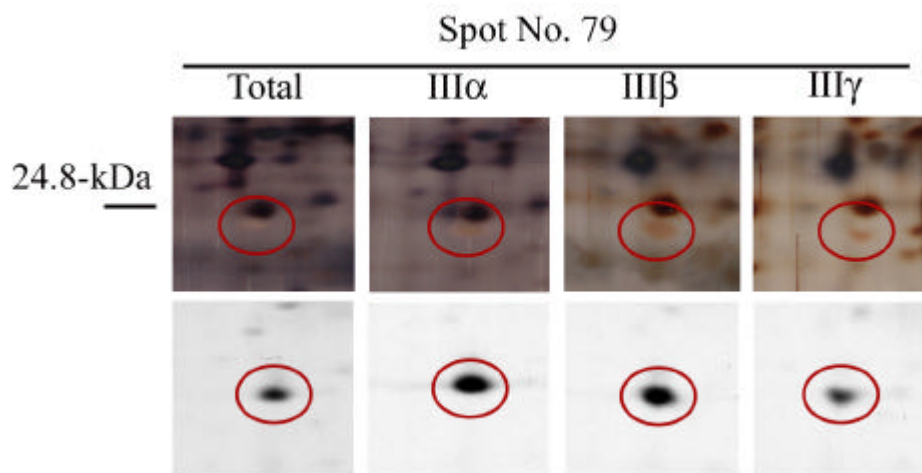
Fig. 32. The 24.8-kDa (spot No.79) was negatively stained by silver-stain (Figs. 16, 17, 18), thus not detected by the 2D analysis software. This negatively stained spot ranged from stage a to ? and presented high intensity of ^{35}S labeling.
